# Manhole Inspection Summary

Manhole # S37KK\_036MH

Insp Date: **3/20/07 10:58 AM**

**Location** Address: **1901 BARCLAY ST**

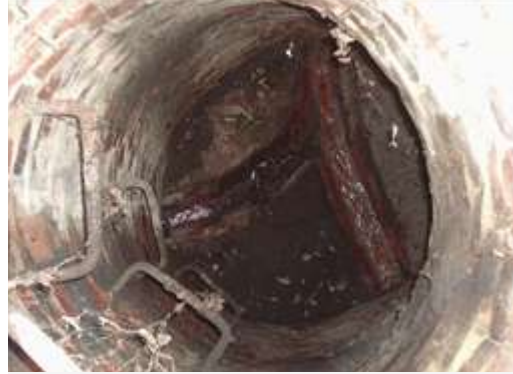
Top View

Barrel infiltration. Corroded steps.  
Evidence of surcharge - Bench debris.

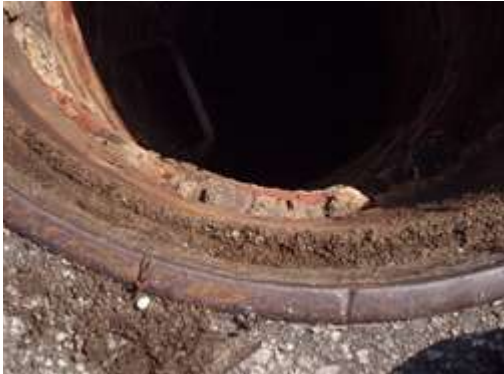
Defect

Frame leaks. Frame offset. Adjustment  
infiltration.

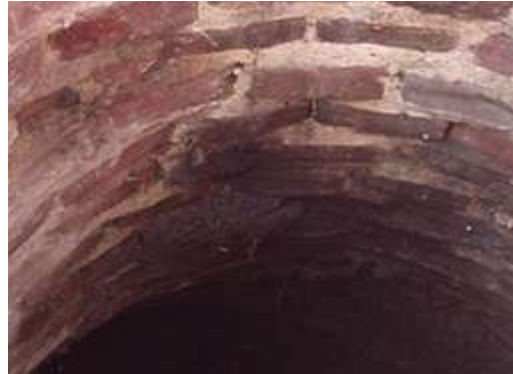
Defect

Corbel and Barrel infiltration.

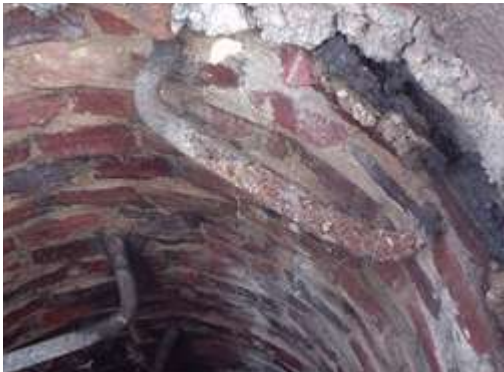
Defect

Frame leaks. Adjustment deterioration  
and infiltration. Corbel and Barrel  
infiltration.

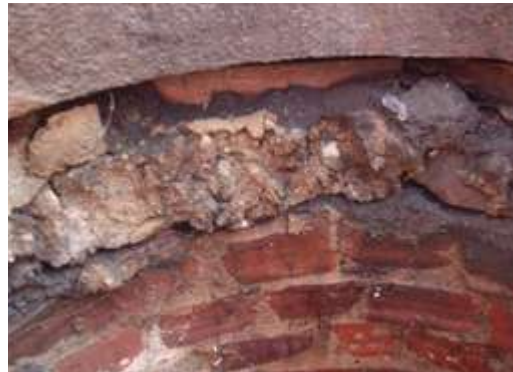
Defect

Frame leaks. Adjustment deterioration  
and infiltration.

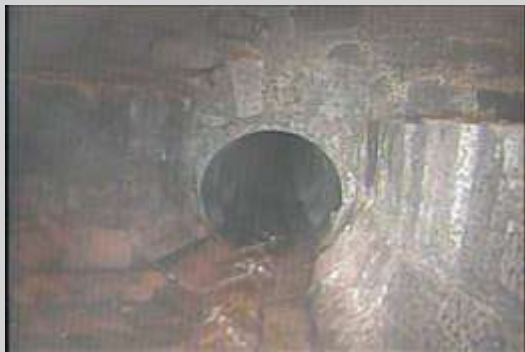
### 8 in. Circular Gravity Sewer Pipe Out @ 12 O'Clock

Pipe Material: **Clay** ☐ Pipe Lined

Invert Depth: **10.79** (ft.) Flow Characteristics: **Slow**

Infiltration: **None** Pipe Seal Cond: **Unknown**

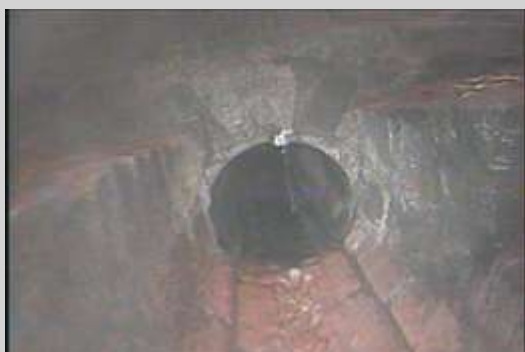
### 8 in. Circular Gravity Sewer Pipe In @ 5 O'Clock

Pipe Material: **Clay** ☐ Pipe Lined

Invert Depth: **10.61** (ft.) Flow Characteristics: **Slow**

Infiltration: **None** Pipe Seal Cond: **Unknown**

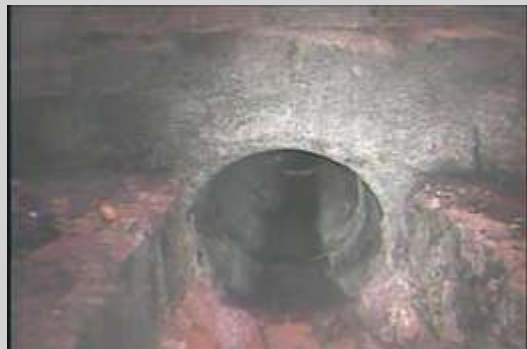
Pipe In @ 9 O'Clock

Pipe Material: **Clay**

Invert Depth: **10.74** (ft.) Flow Characteristics: **Slow**

Infiltration: **None**
